February 2, 2004

## REPLACEMENT UNITS FOR 604 & 606

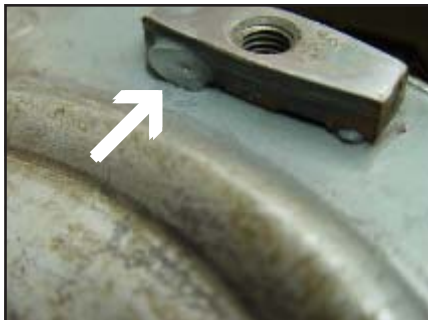
A leak or signs of leak in the pad area is a sure sign that the cover is cracked. A cracked cover can not be used in remanufacturing.

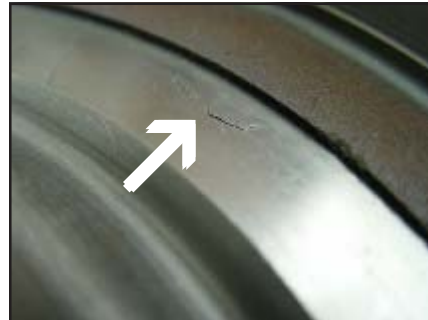
The cracked cover at the mounting lug has created a crack in the area of the cover that is used as the apply face for the lock-up clutch.
